# RECONNAISSANCE REPORT OF DAMAGE TO HISTORIC MONUMENTS IN CAIRO, EGYPT FOLLOWING THE OCTOBER 12, 1992 DAHSHUR EARTHQUAKE

**Reconnaissance Report of Damage  
to Historic Monuments in Cairo, Egypt  
Following the October 12, 1992 Dahshur Earthquake**

Technical Report NCEER-93-0016

August 19, 1993

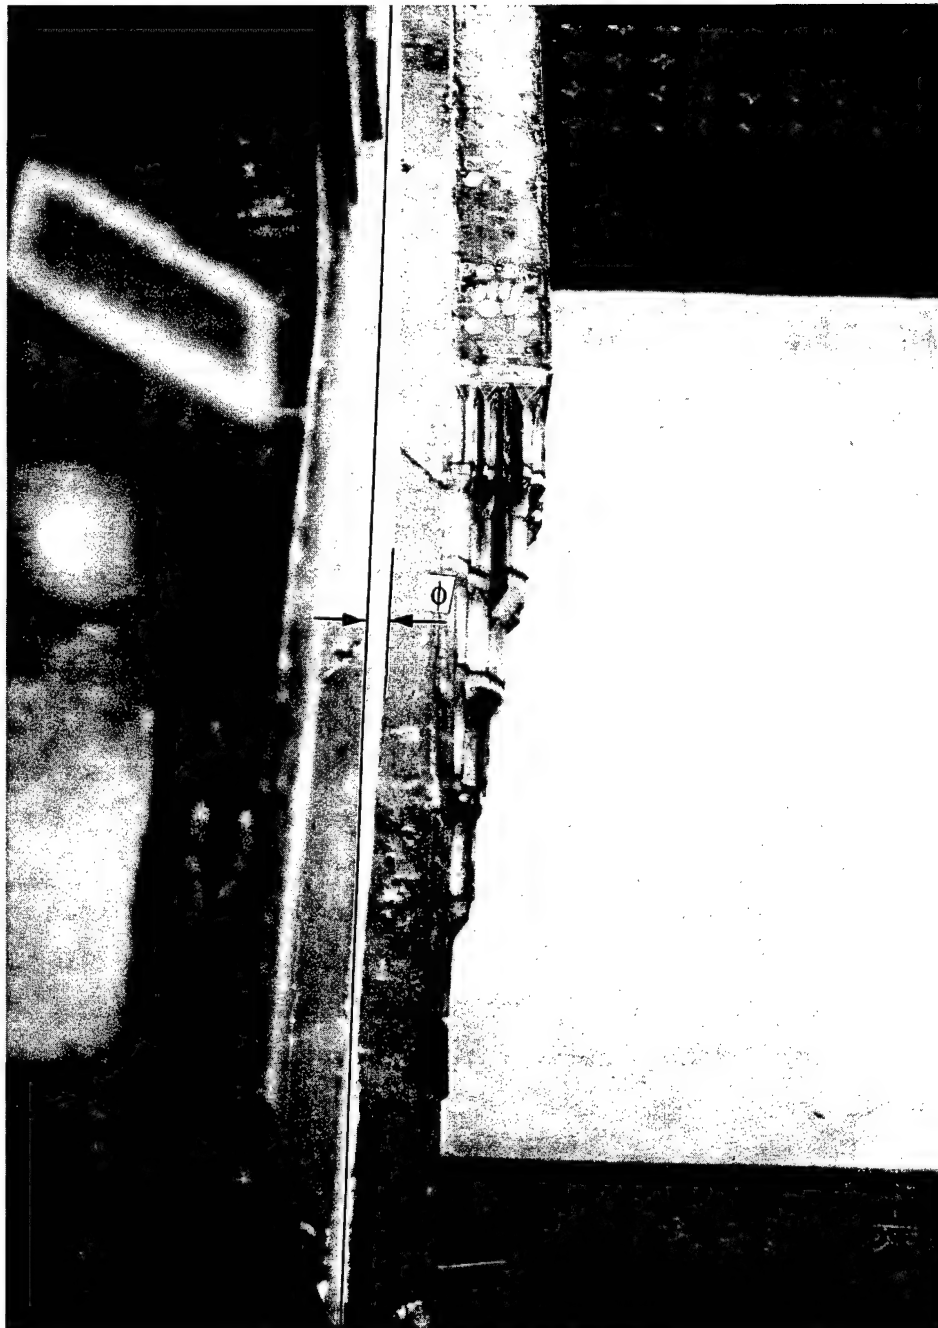
**FIGURE 4-47** Interior wall and column at Bayt as-Sihaymi showing out-of-plumb column

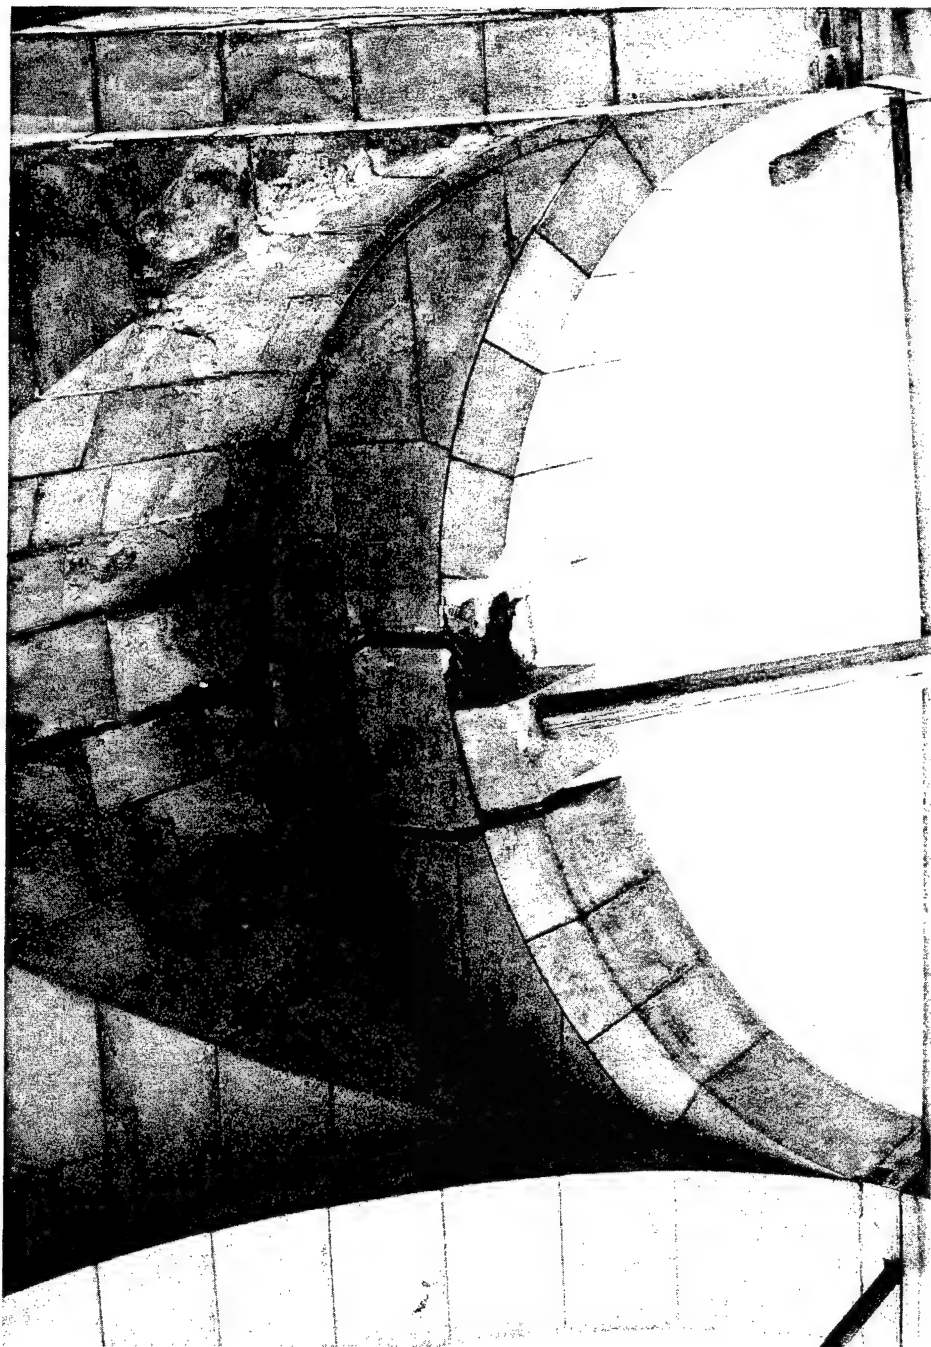
**FIGURE 4-49 Arch of portico to Saraya el-Adl at Citadel showing missing stone, large cracks, separation, and distortion**

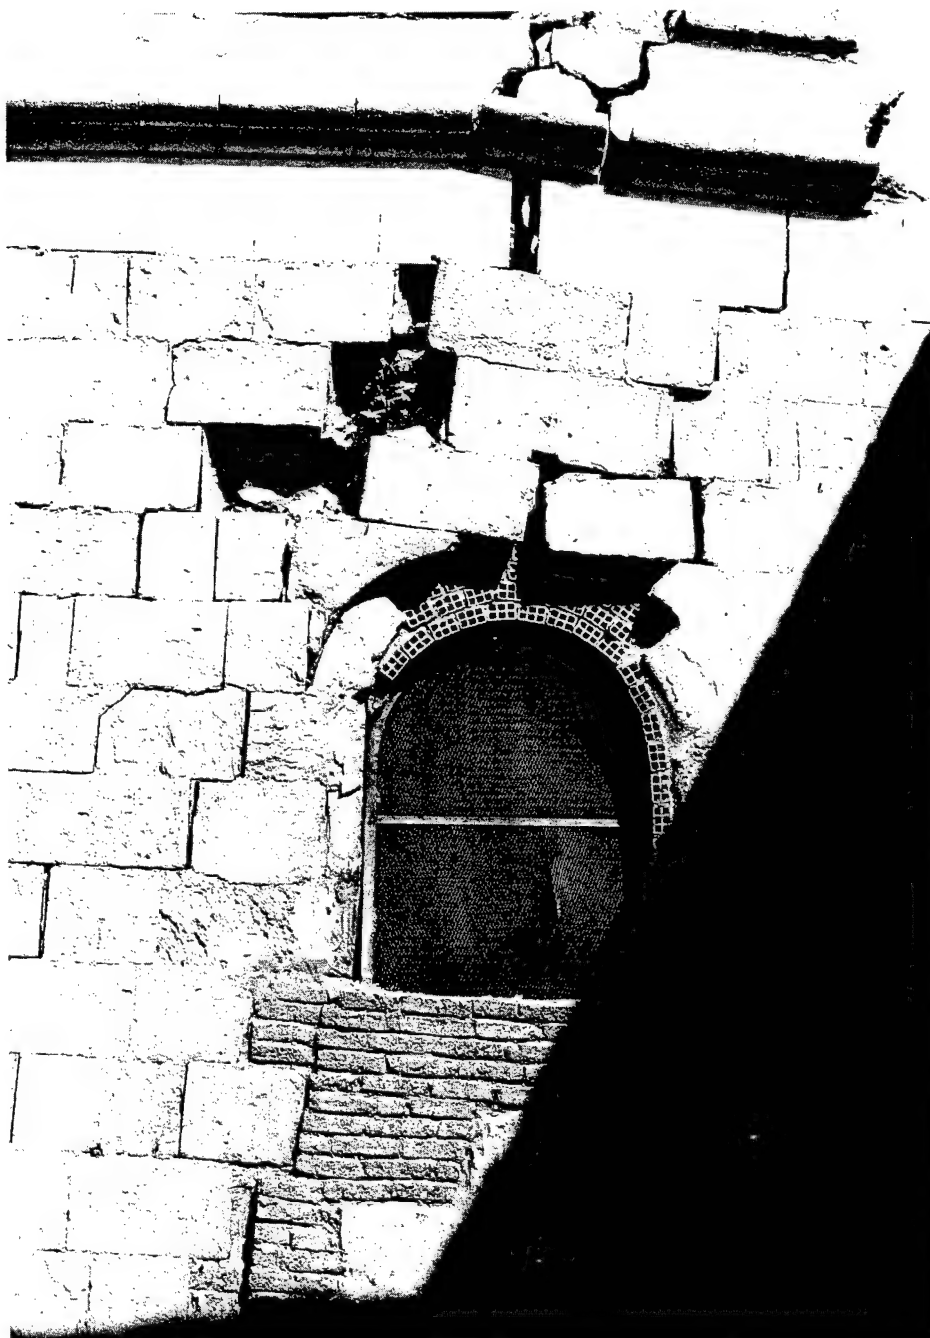
**FIGURE 4-50** Back wall of Saraya el-Adl at Citadel showing missing stones, large cracks and separation

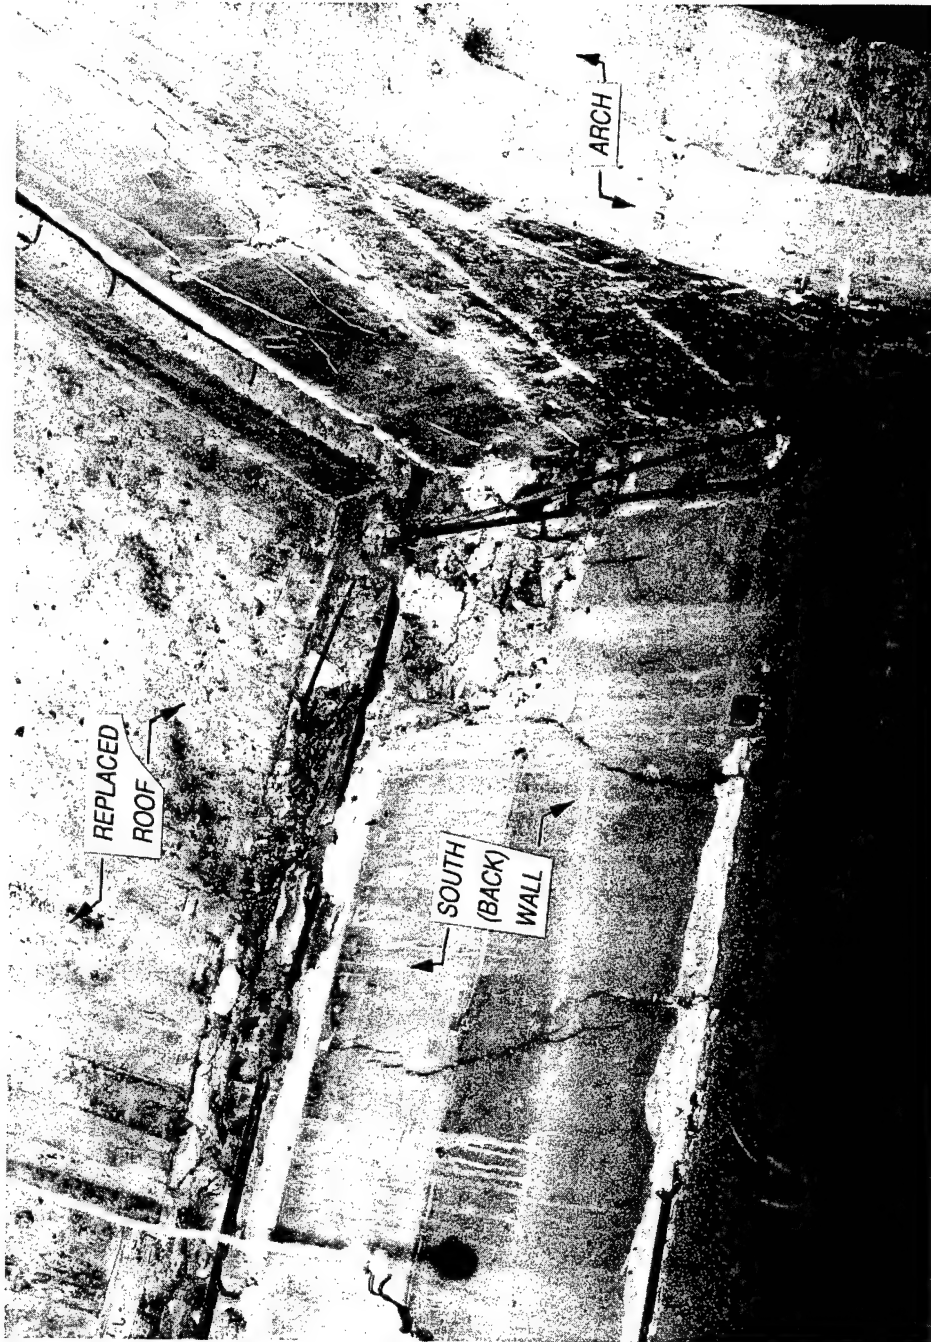
**FIGURE 4-51** Interior south wall of Saraya el-Adl looking up at contact between wall, arch, and concrete ceiling showing cracks, separation, and distortions

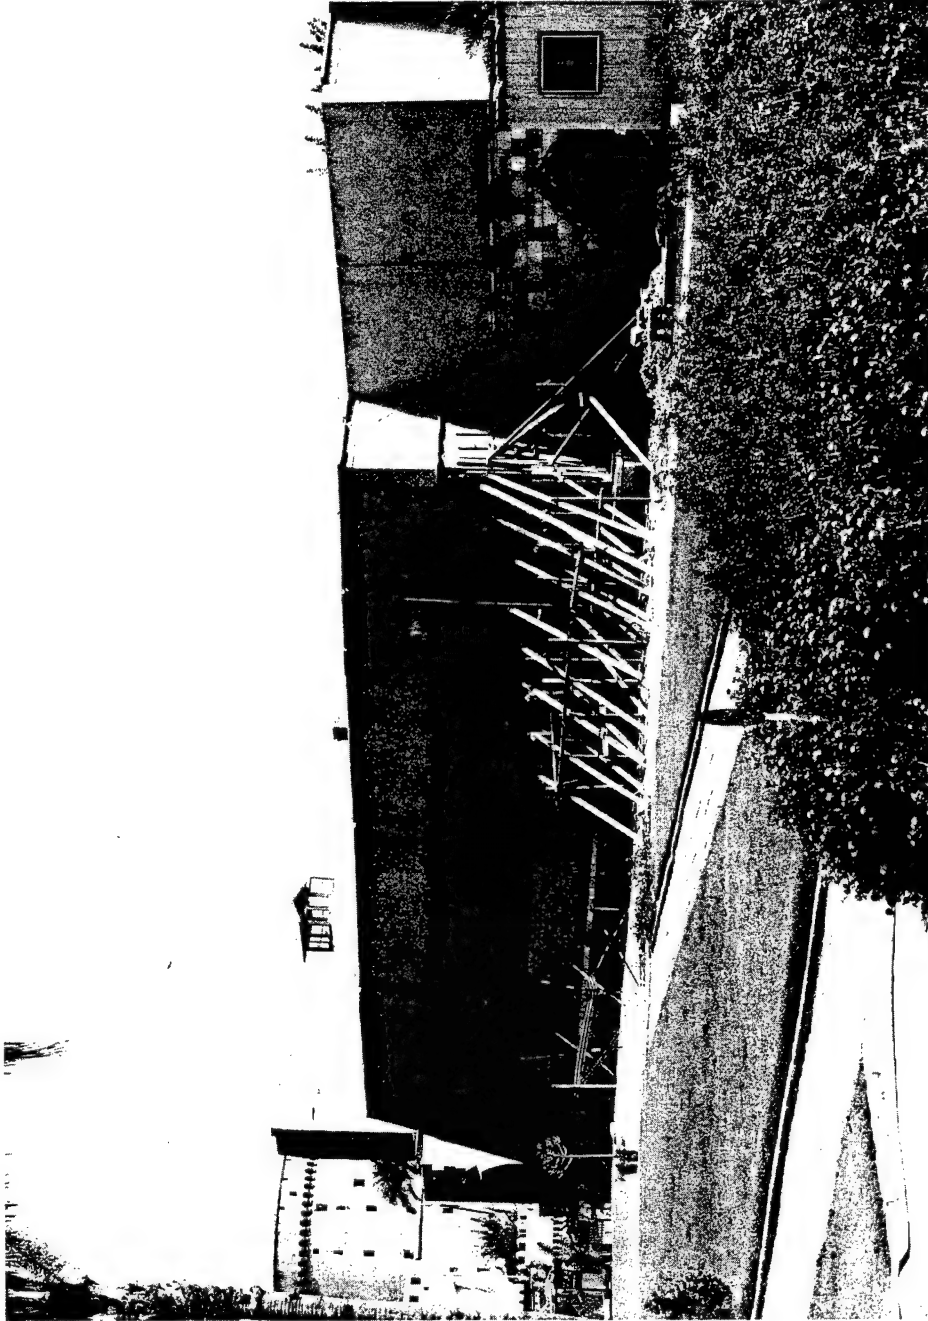
The Mint at the Citadel is a small, one-story, stucco-covered brick structure located near the Bāb al-Gabal. Damage to walls and small domes of the structure was extensive but very isolated to the southwest corner as shown in figures 4-52 and 4-53. External bracing had been placed but the cracks seemed to widen over the week of the team's visit. The combination of the severity and isolated nature of this damage suggests that fill and/or rubble exists beneath the foundation at this corner. Underpinning of the foundation may provide a means to correct this problem and prevent severe damage in the future.

**FIGURE 4-52** Collapsed southwest corner of Mint at Citadel showing large crack and separation and external bracing

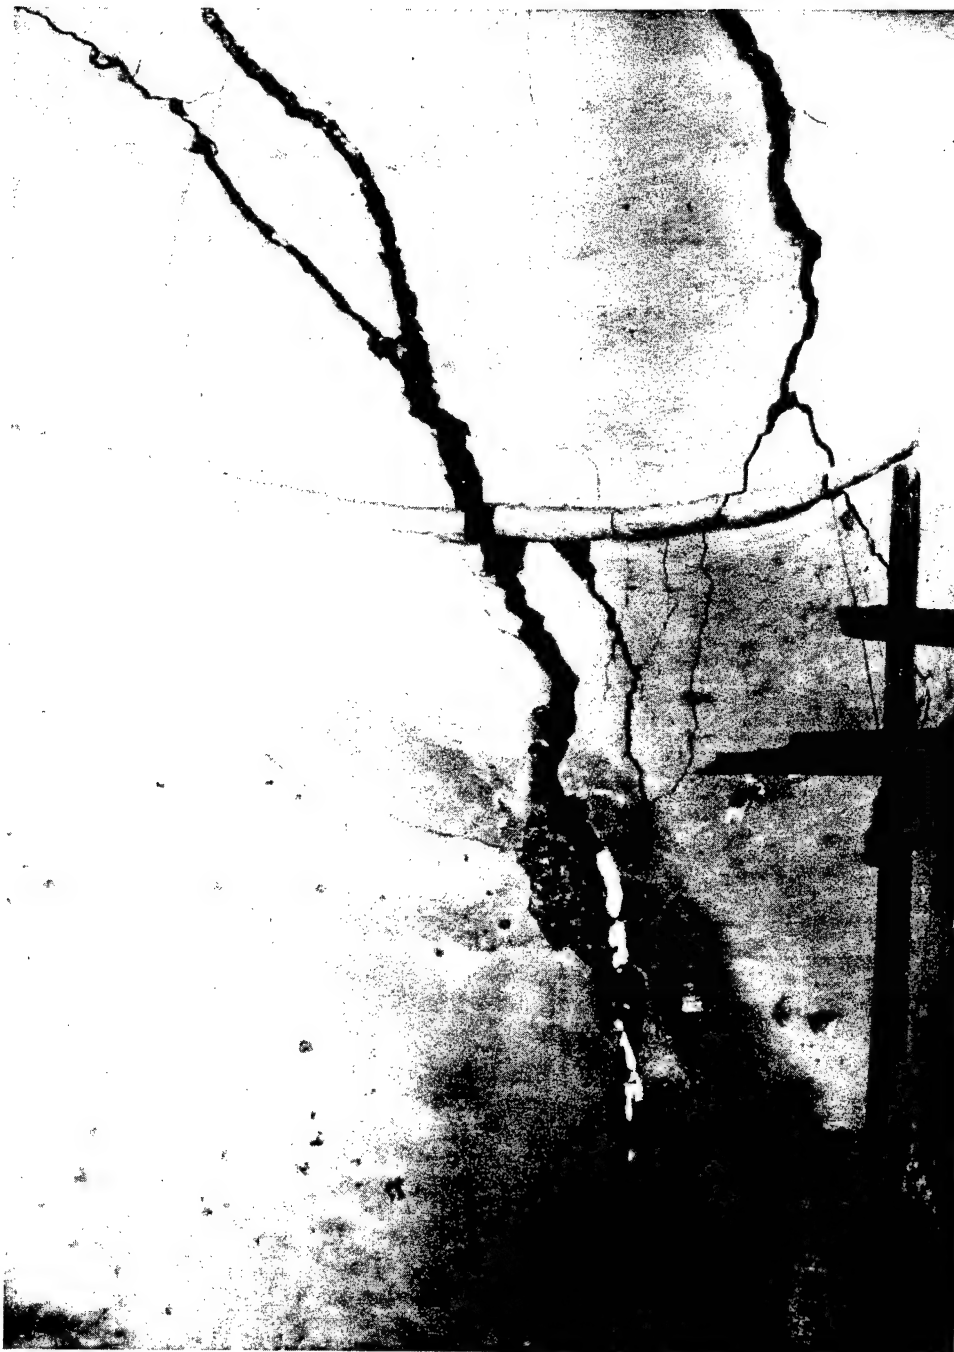
**FIGURE 4-53** Interior minor dome near southwest corner of Mint at Citadel showing large cracks and separation
